NASA Technical Memorandum 88996

BUCKLING TESTS OF A 10-FOOT DIAMETER STIFFENED CYLINDER WITH RECTANGULAR CUTOUTS

RANDALL C. DAVIS AND FRED CARDER

FEBRUARY 1987

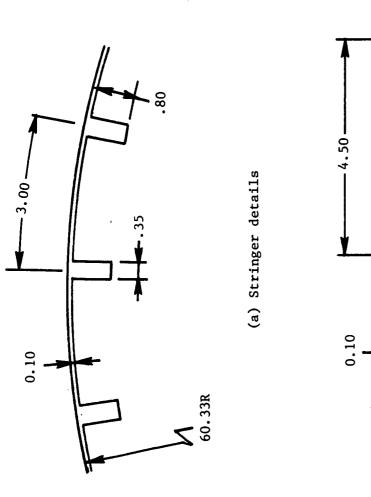
Figure 1.- Geometric details of the shell wall (dimensions in inches).

(b) Ring details

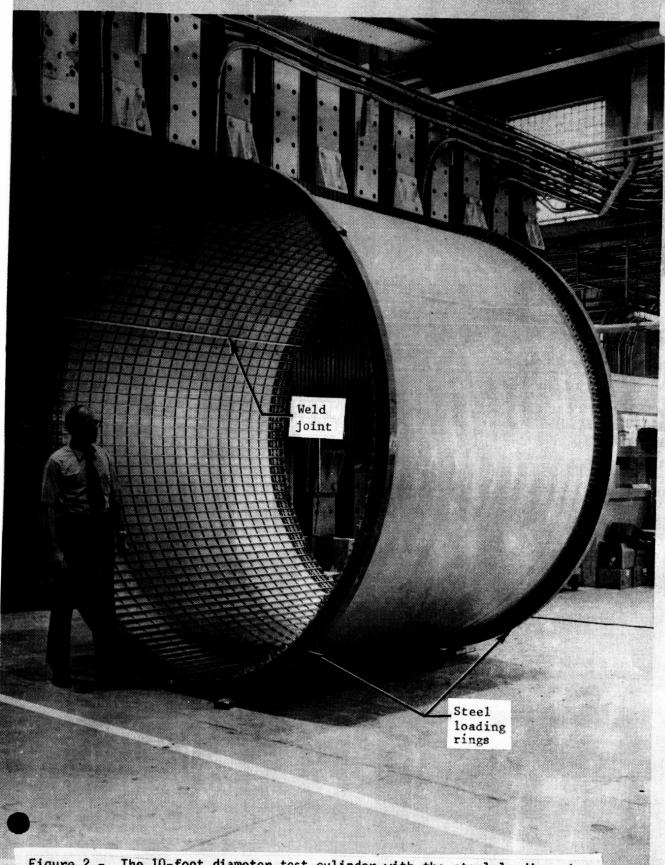
Figure 2.- The 10-foot diameter test cylinder with the steel loading rings attached to the ends of the shell.

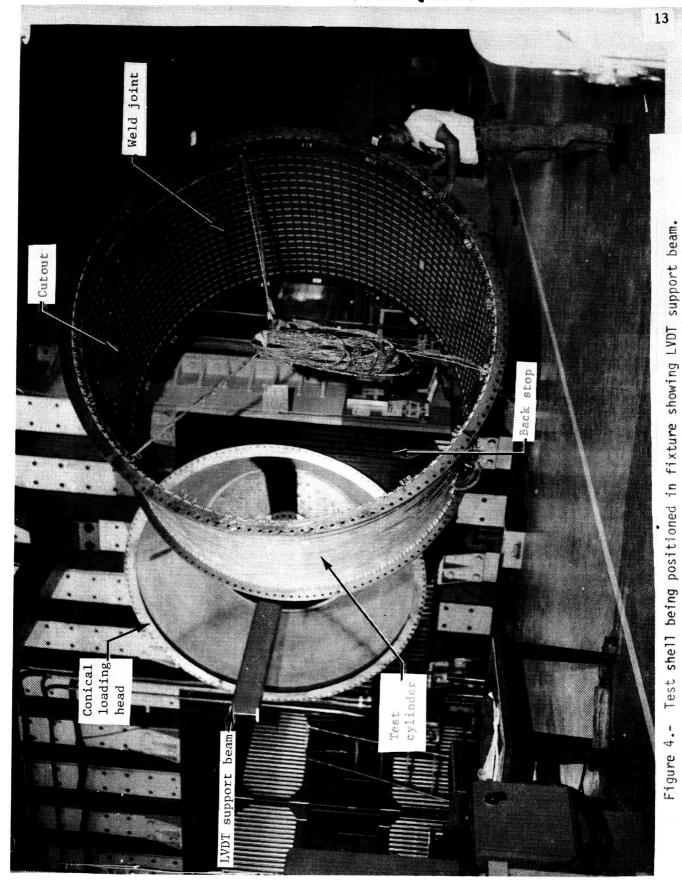
Figure 4.- Test shell being positioned in fixture showing LVDT support beam.

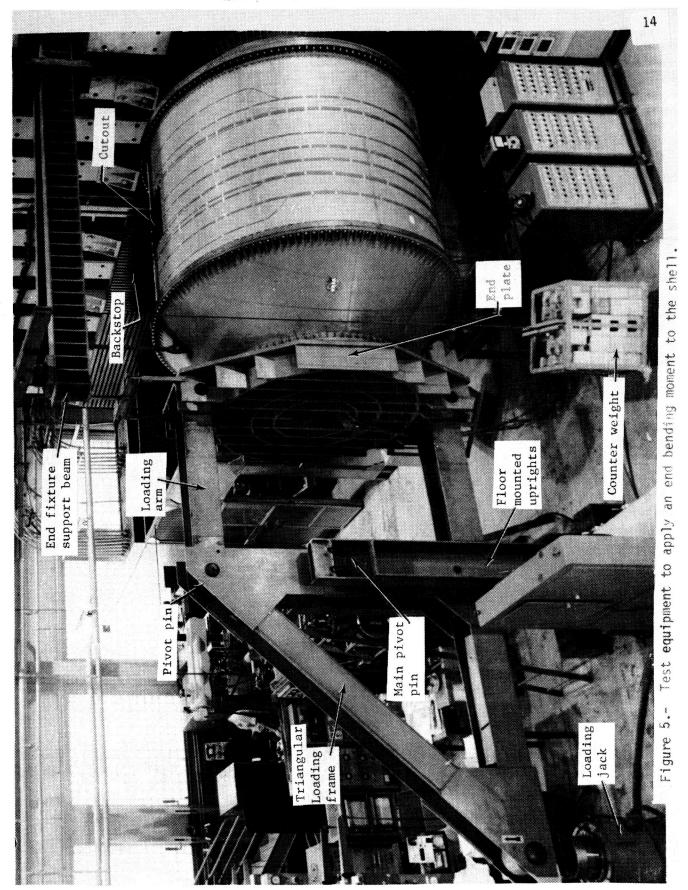
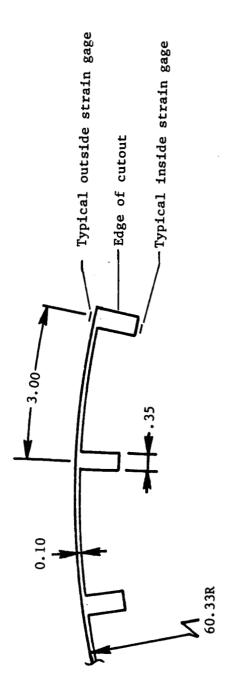
(a) Typical location of back to back longitudinal strain gages on stringers at the edge of the cutouts

(b) Typical location of back to back circumferential strain gages on rings at the edge of the cutouts

Location of strain gages placed around the edges of the cutouts. Figure 6.-

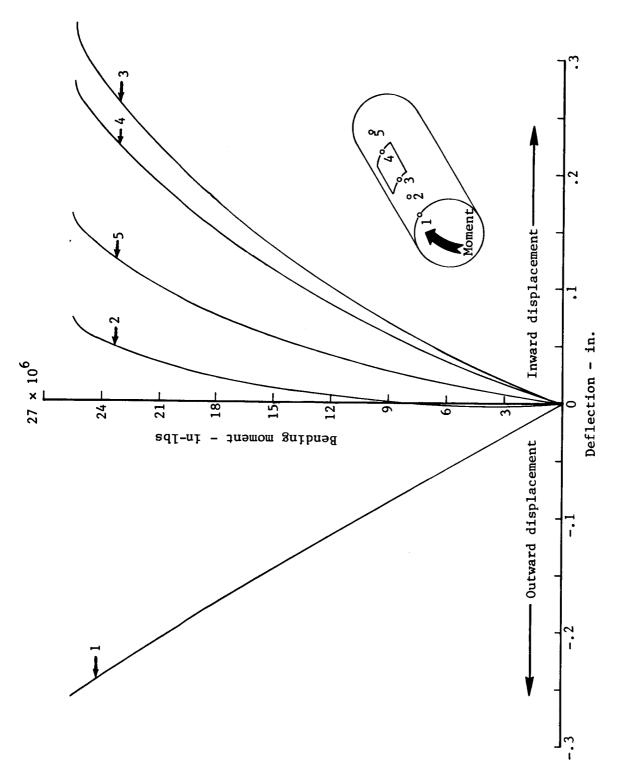
Figure 7.- Deflection on top centerline for 18x18 inch cutout.

The shell with the 18x18 inch cutout, loaded to failure by an end bending moment, failed suddenly with a loud noise and a large loss in bending stiffness at a bending moment of 25,500,000 in-1bs (Table I). The displacements from the LVDT's for this test are shown in figures 7 and 8 and the position of each LVDT is marked with a numeral on the inset. The corresponding response curve is marked with the same numeral. The displacements along the top generator line of the cylinder shell wall are nonlinear as can be seen in figure 7. From figure 7, note that the top of the shell wall at the loaded end of the cylinder moved almost linearly, but the rest of the shell wall moved non-linearly inward toward the centerline of the shell (a phenomenon also noted in ref. 6). seen in figure 8, the load-displacement responses were nonlinear around the edges of the cutout. The edges of the cutout area all began to move inward above 6,000,000 in-lbs. Approaching the failure load, the deflection at locations 9, 10, and 11 on the right side of the cutout (facing the back-stop) reversed direction and began to buckle outward at about 25,000,000 in-1bs. The deflections at locations 6, 7, and 8 on the left side of the other hand began tp buckle inward. The shell finally failed in an asymmetric mode with the right side buckled out and the left side buckled inward, as can be seen in the photograph in figure 9.

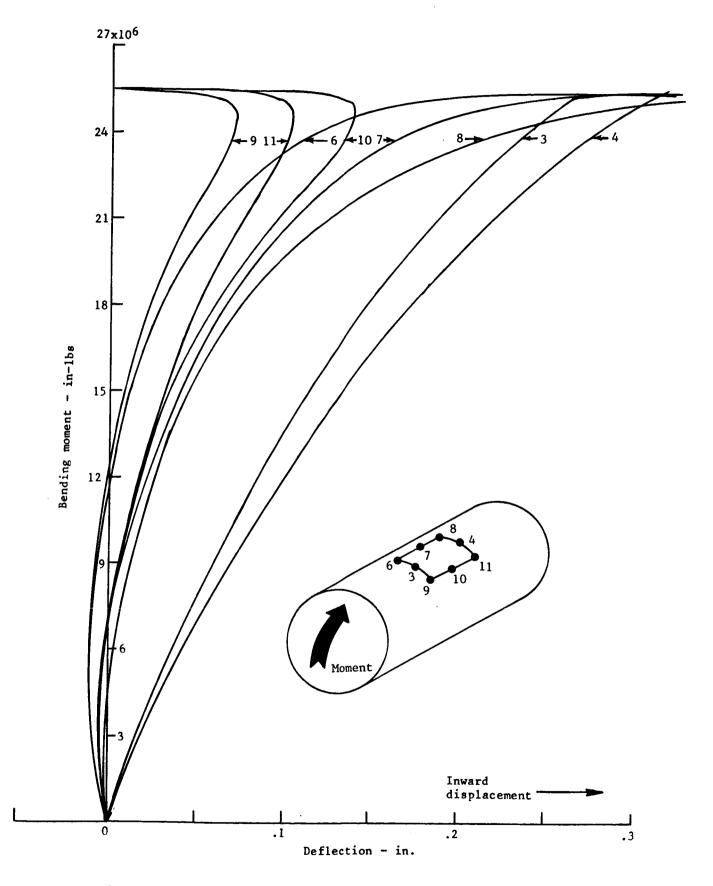
Figure 8.- Deflections around edge of 18x18 inch cutout.

The back-to-back strain gage responses from 32 gages and their 16 locations around the 18x18 inch cutout are shown in figures 10 through 13. Figures 10 and 12 show the locations of the strain gages, which are all centered halfway between stiffener centerlines. The longitudinal strains adjacent to the cutout area at longitudinal positions A and D, figure 11, showed a very nearly linear response with applied bending moment. Bending of the edge stringers near the center of the cutout, as evidenced by the separation in the back-to-back gage response curves at longitudinal positions B and C, became prominent above an applied moment of 10,000,000 in-lbs, resulting in a strain reversal which occurred at 20,800,000 in-lbs. Upon examination of the inside-outside response curves, it was seen that the right side of the cutout was bending outward, while the left side is bending inward. The strain reversal at 20,800,000 in-lbs precedes the deflection reversal shown in figure 8 and the shell buckling at 25,500,000 in-lbs.

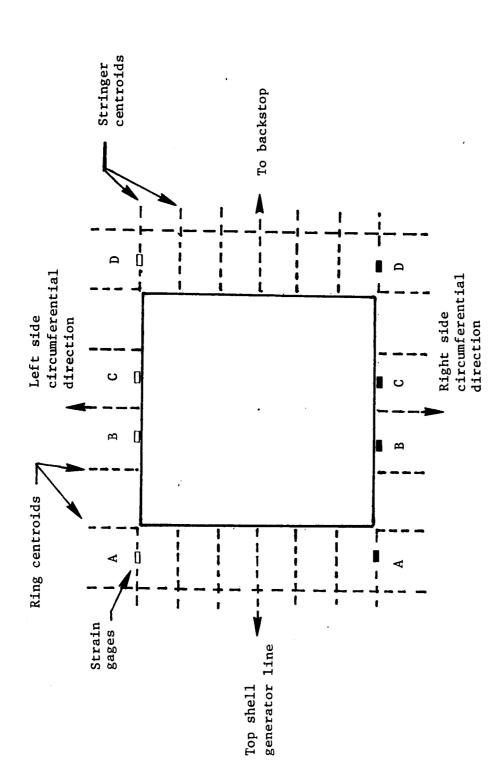
Figure 10.- Locations for longitudinal strain gages along right and left sides of 18x18 inch cutout.

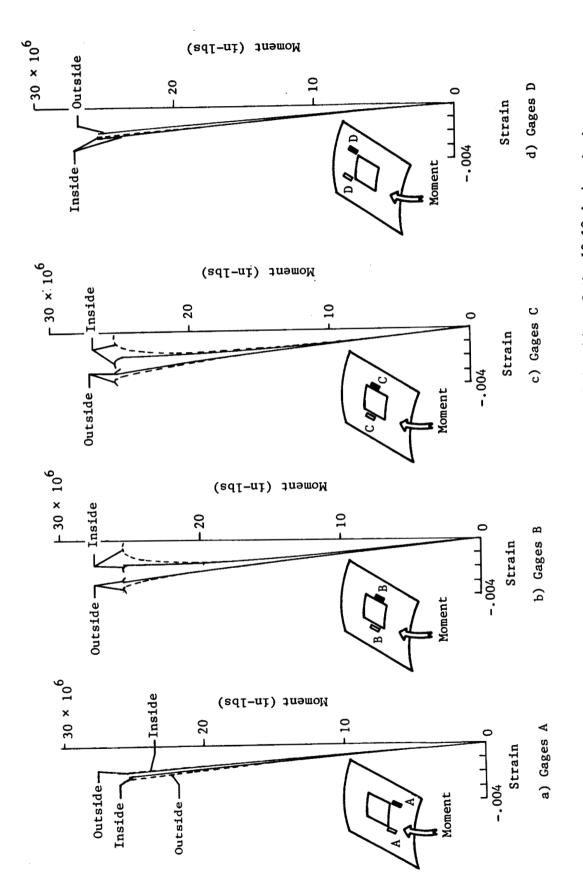
Figure 11.- Longitudinal strains on the right and left sides of the 18x18 inch cutout.

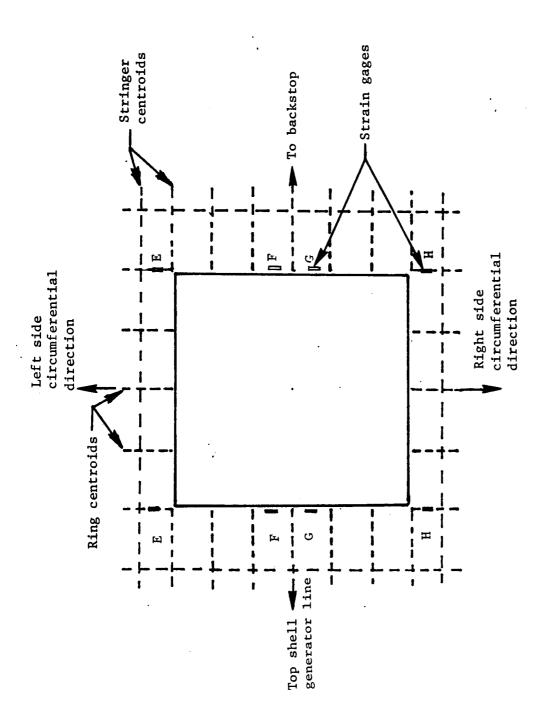
Location of circumferential strain gages along front and back edges of 18x18 inch cutout. Figure 12.-

The circumferential strains for the 18x18 inch cutout, as shown in figure 13, are symmetric about the midspan of the cutout front and back edges. The corner areas at circumferential positions E and H adjacent to the cutout showed very little circumferential strain present. At the circumferential positions F and G near the midspan of the cutout edge, the back-to-back gage responses showed tensile strains with bending of the ring at the edge of the cutout, taking place from the onset of loading. In addition, these results showed that the front and back edges of the cutout were bending inward.

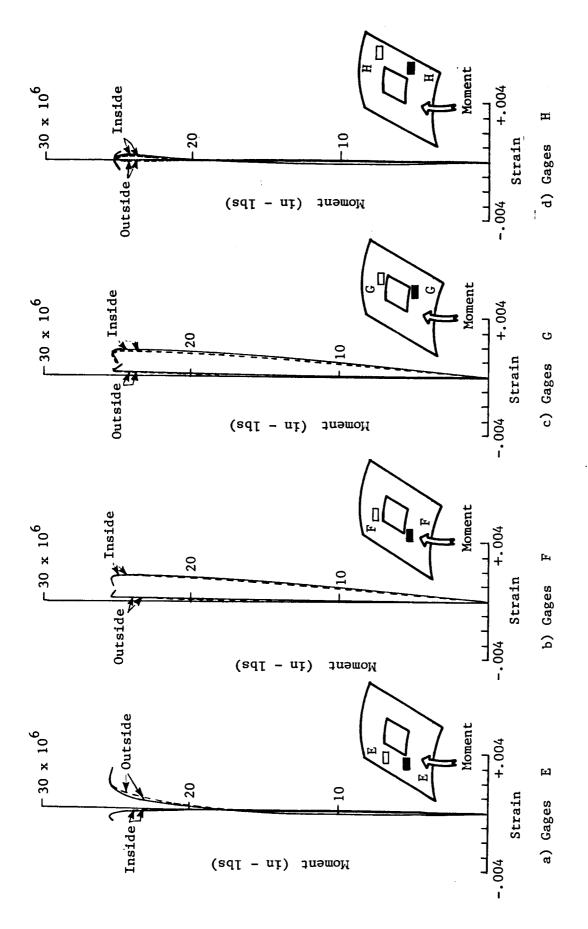
Figure 13.- Circumferential strains along front and back edges of 18x18 inch cutout.

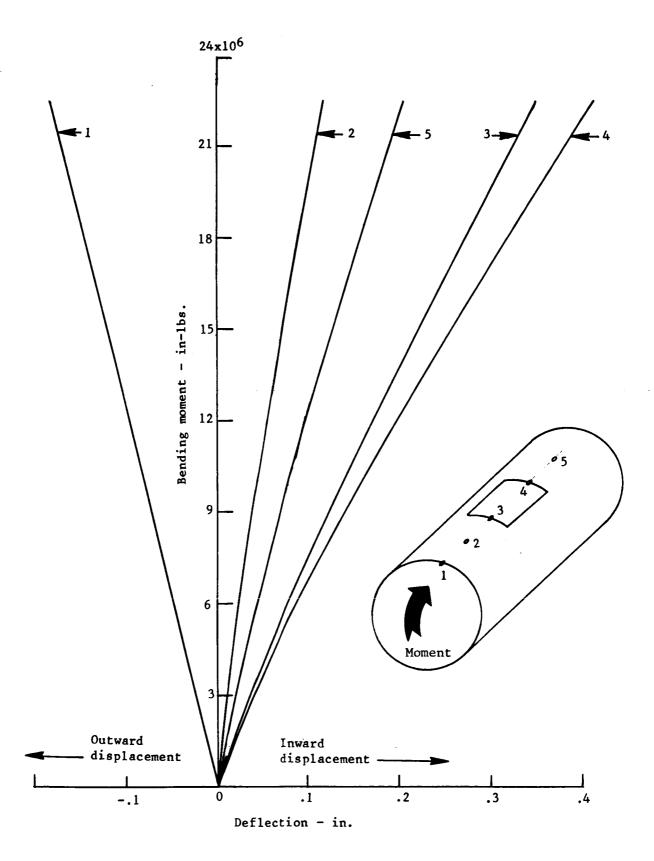
Figure 14.- Deflections along top centerline for 24x27 inch cutout.

The shell with the 24x27 inch cutout failed suddenly with a loud noise and a sudden loss in bending stiffness at an applied bending moment of 22,600,000 in-lb (Table I). The test displacement results are shown in figures 14 and 15. The top of the shell wall at the loaded end of the cylinder moved nearly linearly but the cutout area began to move nonlinearly inward relative to the unloaded position from the onset of loading, as can be seen from figure 14. The deflections around the edge of the cutout, shown in figure 15, showed that the right side of the cutout (facing the backstop) reversed its inward movement near 22,000,000 in-lbs and began to buckle outward. The left side on the other hand, began to buckle inward. The cutout area buckled asymmetrically, as can be seen figure 16, with the right side bowed outward and the left side buckled inward.

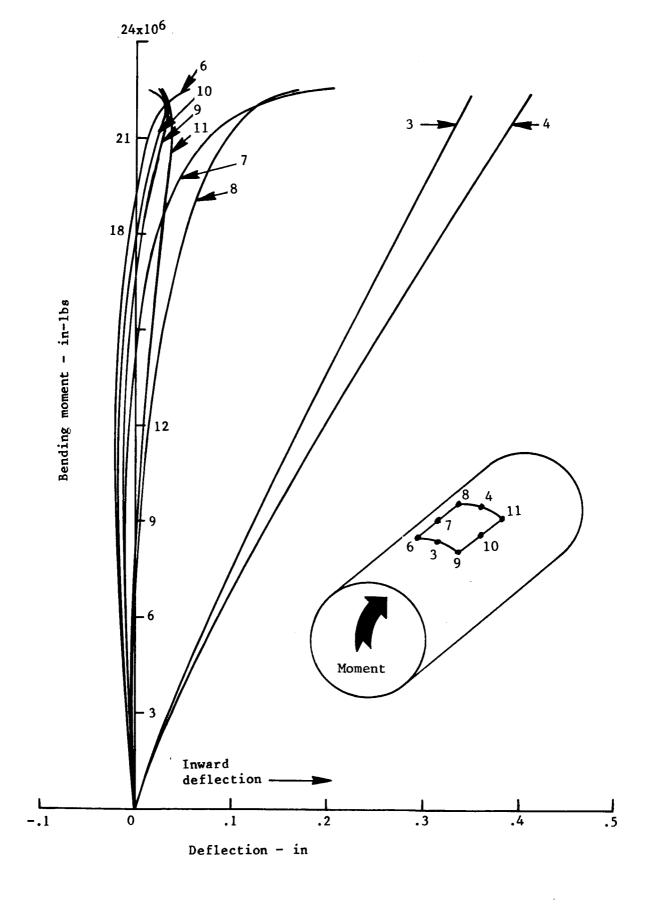
Figure 15.- Deflections around edge of 24x27 inch cutout.

The back-to-back strain gage response curves from 44 gage and their 20 locations around the 24x27 inch cutout are shown in figures 17 through 20. As can be seen from figure 18, the longitudinal strains were symmetric about the midspan of the edges of the cutout area. The longitudinal strains at positions A and F, just out from the corner, showed a high degree of linearity and very little bending. Bending of the right and left edge stringers between the midspan and corners, as evidenced by the separation in the back-to-back strain gage response curves at positions B through E in figure 18, began early with applied loading, resulting in a strain reversal at 21,100,000 in-lbs. The longitudinal strain responses in general appear to be more linear than the displacement curves in figures 14 and 15 indicate. An examination of the inside-outside response curves from right side to left side of the cutout in figure 18 revealed that the right side of the cutout was bending outward and the left side inward as indicated by the displacement results in figure 15.

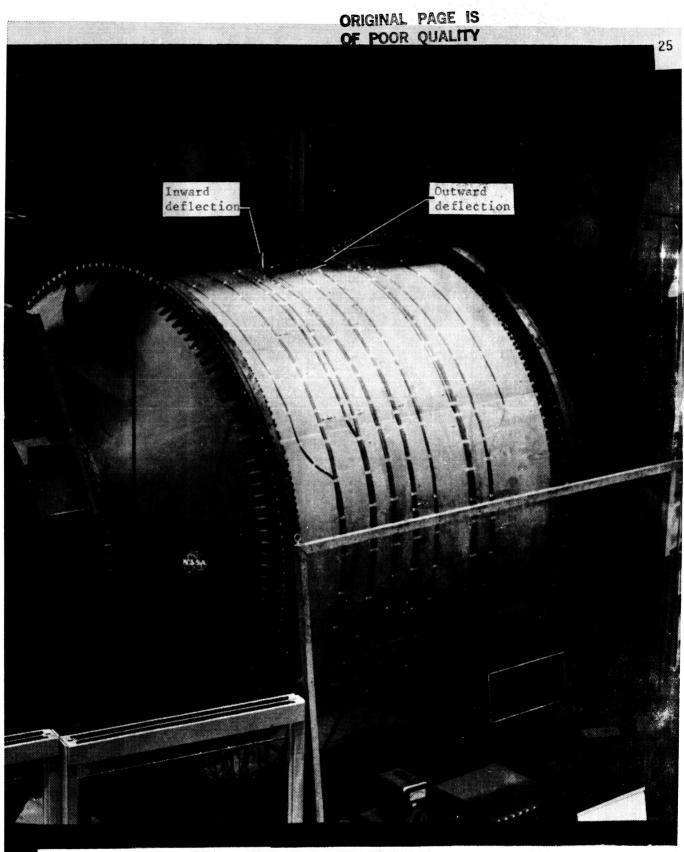
Figure 16.- Photograph of buckled cylinder showing buckled mode shape around 24x27 inch cutout.

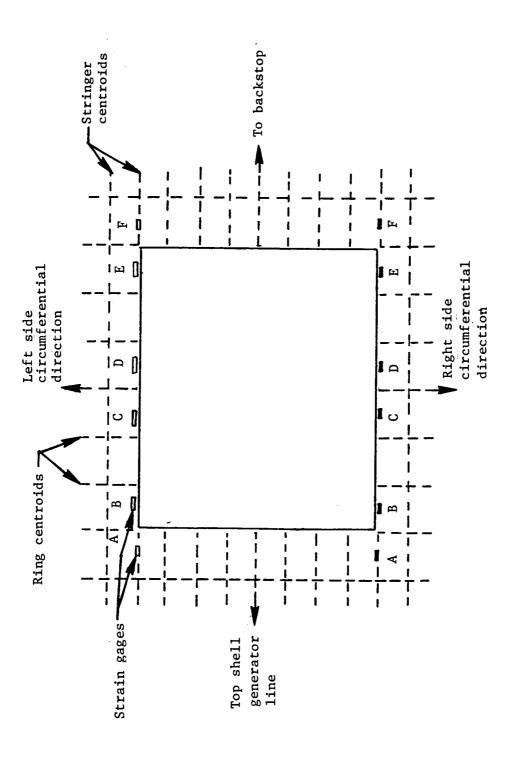
Figure 17.- Locations of longitudinal strain gages along right and left sides of 24×27 inch cutout.

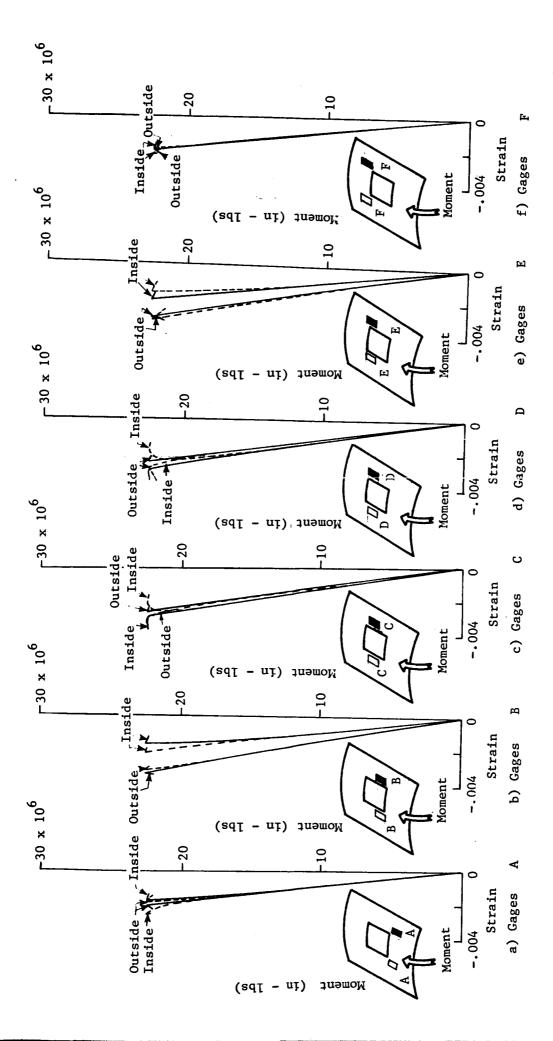
Figure 18.- Longitudinal strain along right and left side of 24x27 inch cutout.

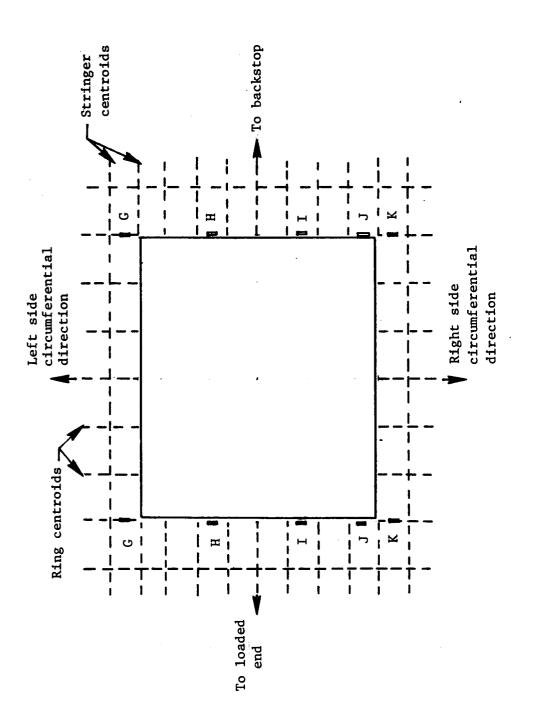
Figure 19.- Location of circumferential strain gages along front and back edges of 24x27 inch cutout.

The circumferential strains for the 24x27 inch cutout, as can be seen in figure 20, exhibited symmetry about the midspan of the front and back edges. The corner gages at circumferential positions G and K, figure 19, showed very little strain while the gages at circumferential positions H through J nearer to the middle span show some tensile strain in addition to bending of the ring on the cutout edge. The bending of the edge stiffener began to take place about half-way through the loading. The inside-outside strain gages responses show that the center of the front and rear edges were bending inward.

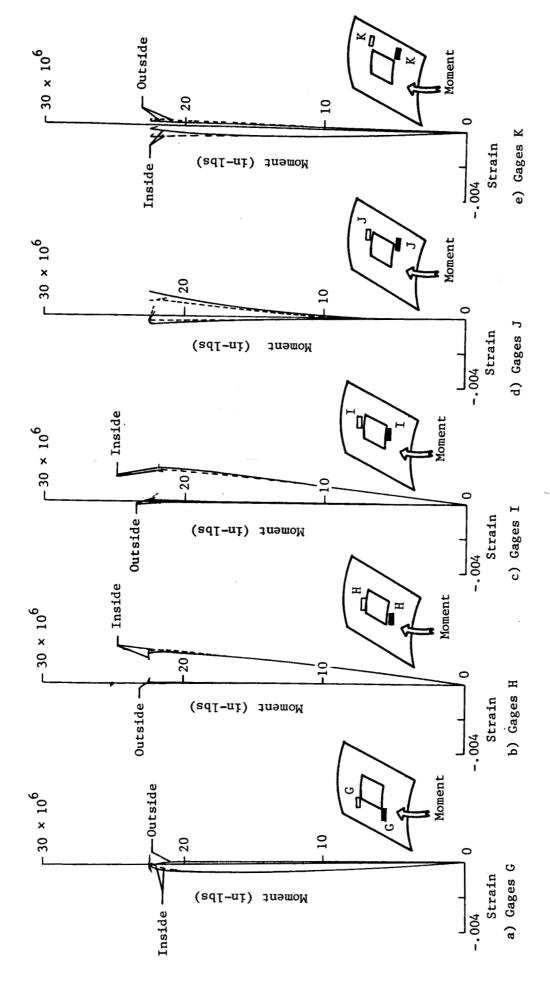
Figure 20.- Circumferential strains along front and back edges of 24x27 inch cutout.

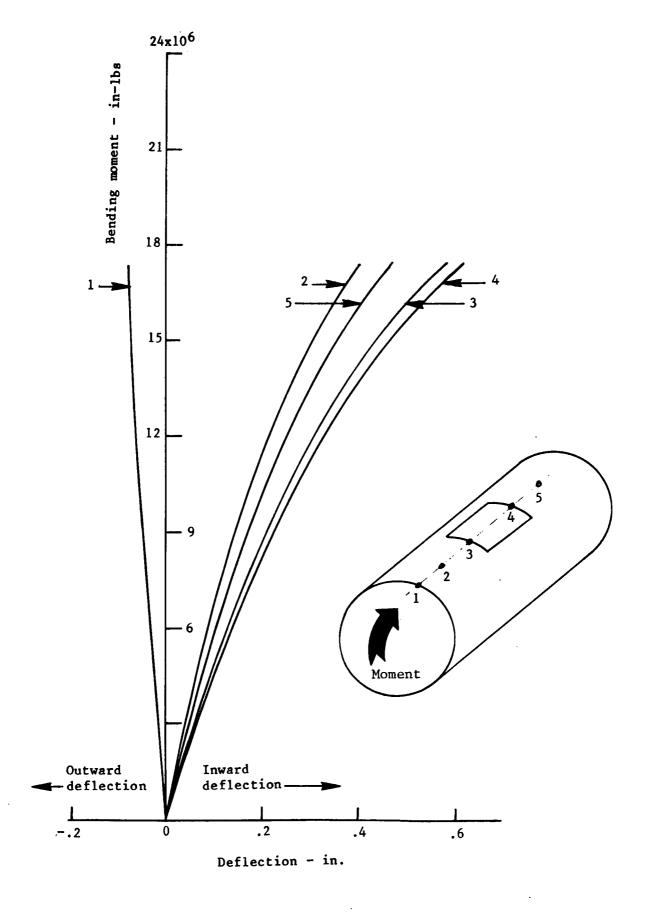
Figure 21.- Deflections along top centerline for 36x36 inch cutout.

The shell with the 36x36 inch cutout failed suddenly, with a subdued noise and a sudden loss in bending stiffness at a bending moment of 17,500,000 in-lb Table I). The test displacements are shown in figures 21 and 22. The top of the shell wall at the loaded end of the cylinder moved nearly linearly, but the top of the shell wall on an axial, through the cutout area, began to move inward nonlinearly immediately upon loading as can be seen in figure 21. As can be seen in figure 22, the corners all moved outward while the center of the sides moved outward, substantially more than the corners. The deflections around the edge of the cutout showed a symmetric mode developing with load. Both the right

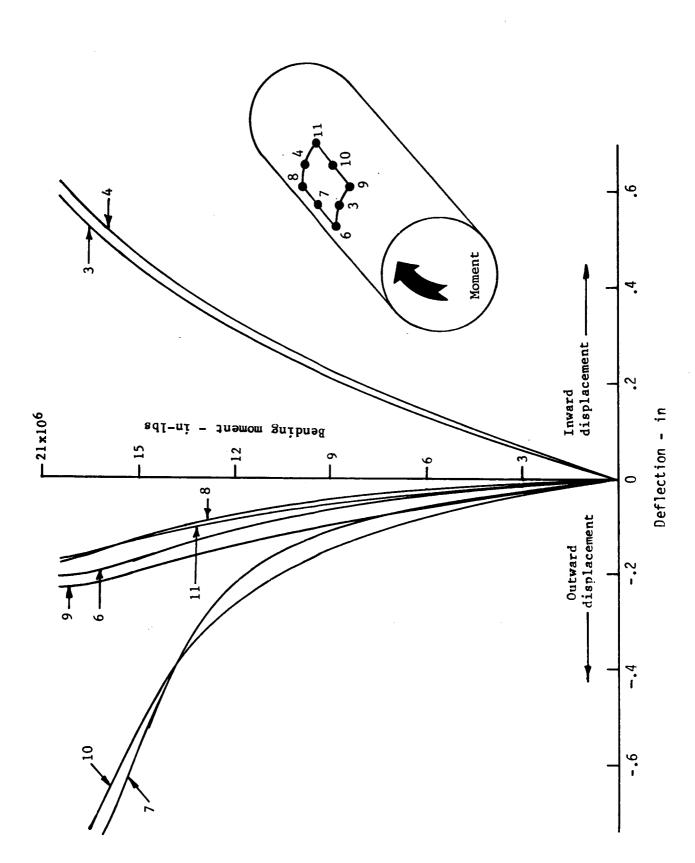
Figure 22.- Deflections around edge of 36x36 inch cutout.

and left sides (facing the backstop) deflected outward with increasing outward motion near failure. There were no deflection reversals for the 36x36 inch cutout. Unlike the two smaller cutout tests, all four corners of the 36x36 cutout area moved outward substantially. The midspan of the front and back edges showed a substantial inward displacement relative to the other displacements. The buckle shape which was symmetric around the cutout can be seen in the photograph in figure 23.

The back-to-back strain gage responses from 24 gages and their 12 locations around the 36x36 inch cutout are shown in figures 24 through 27. As can be seen from figure 25, the longitudinal strains were symmetrical along the cutout edges with respect to the longitudinal direction. Bending of the edge stringer, as evidenced by the separation in the back-to-back strain gage response curves, at longitudinal positions A through C, figure 24, began early with loading, resulting in a strain reversal near 11,400,000 in-lbs. An examination of the inside-outside strain gage response curves from left side to right side confirm the symmetric buckling mode for the cutout area depicted by the displacement curves in figure 22.

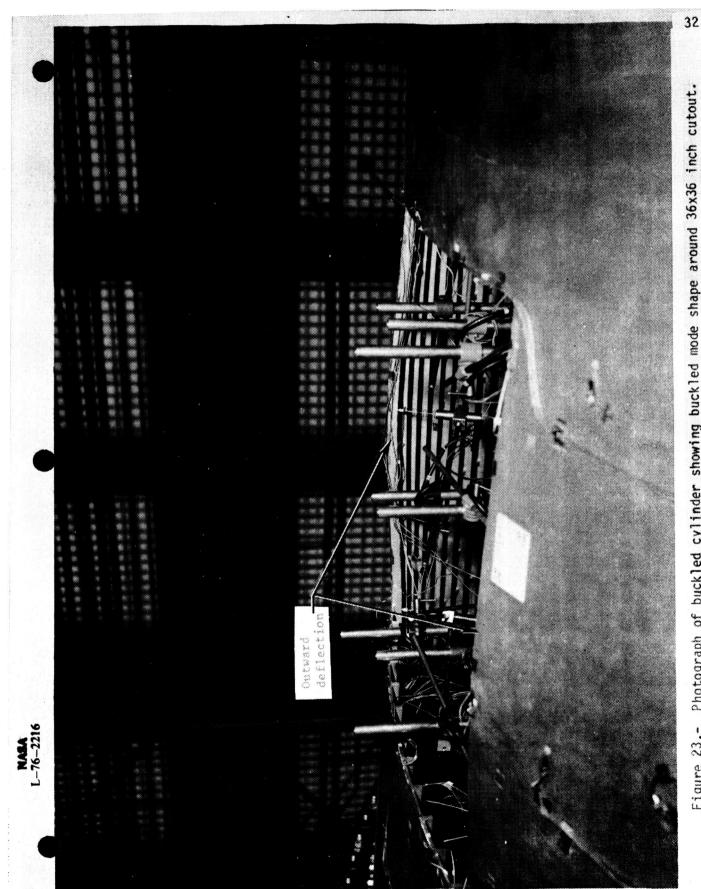
Photograph of buckled cylinder showing buckled mode shape around 36x36 inch cutout. Figure 23.-

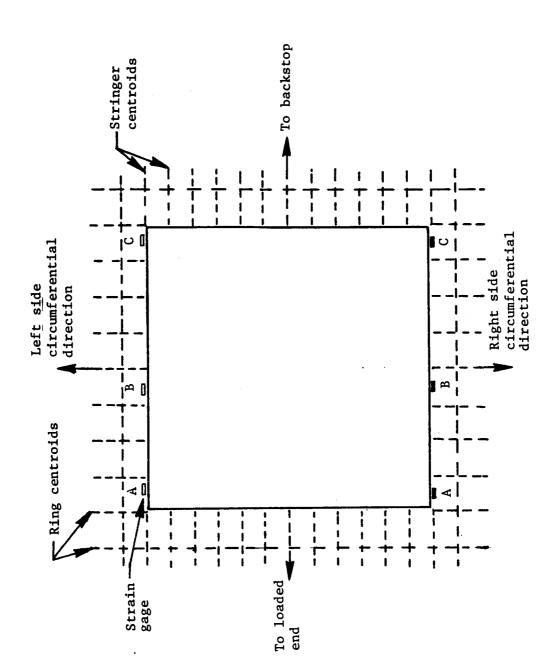
Location of longitudinal strain gages along left and right sides of 36x36 inch cutout. Figure 24.-

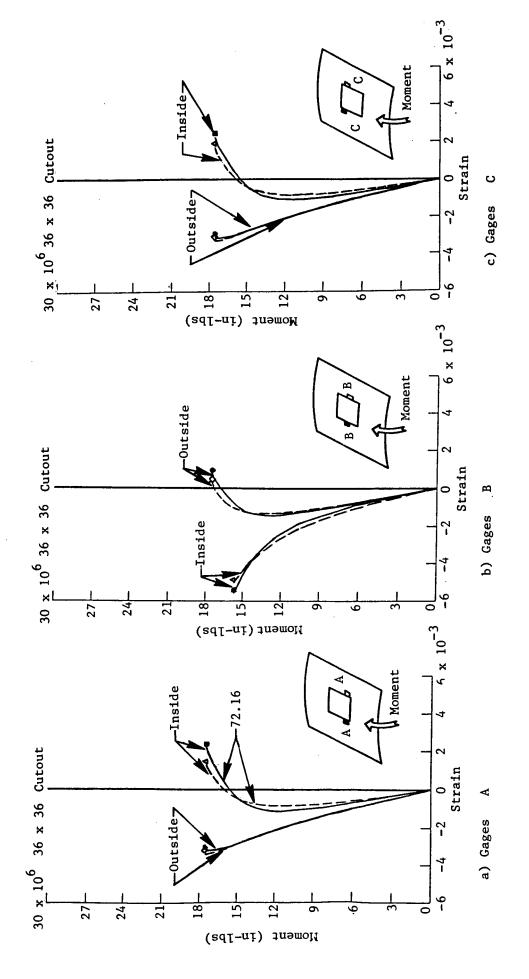
Figure 25.- Longitudinal strains along left and right sides of 36x36 inch cutout.

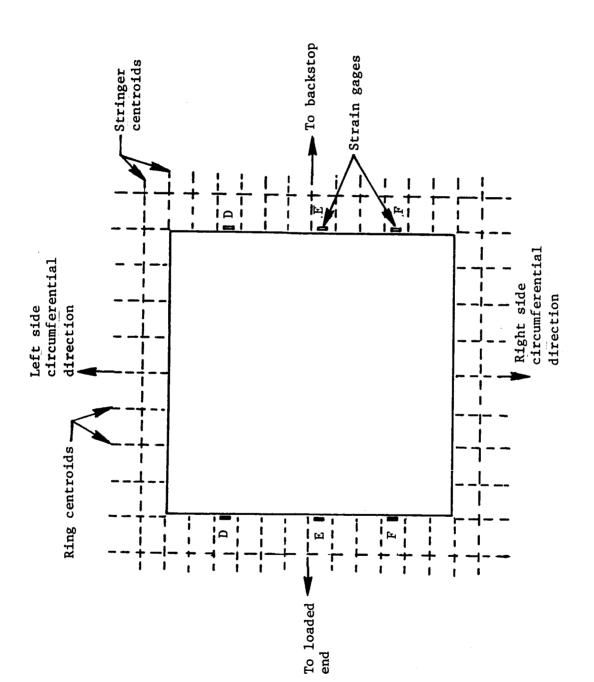
Location of circumferential strain gages along front and back edges of 36x36 inch cutout. Figure 26.-

In figure 27, the circumferential strains near the corners of the 36x36 inch cutout area at circumferential positions D and F, figure 26, remained nearly zero as the loading started but exhibited tensile and bending strains that developed as the shell neared collapse. The circumferential strains exhibited a symmetric bending of the cutout edges for both the right side and the left side of the cutout. At the circumferential position E near the midspan, the circumferential strains were tensile with stiffener bending occurring from the onset of loading. The circumferential strain pattern showed that the right side of the front and back edges were bending inward while the left side was bending outward.

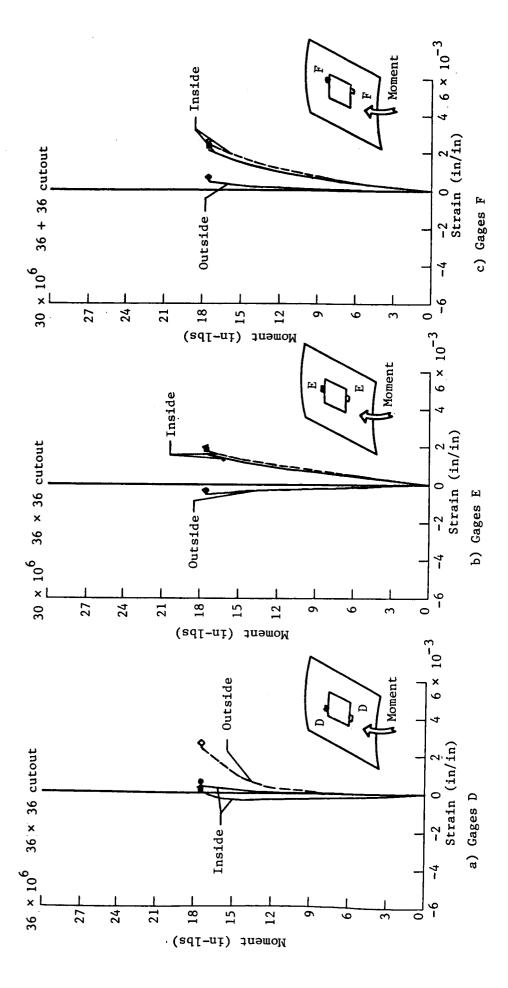
Figure 27.- Circumferential strains along front and back edges of 36x36 inch cutout.
